Full Damp Inspection

Main Building
123 Example Lane

This report contains the findings of an inspection (Full Damp Inspection) carried out at 123 Example Lane on the [REDACTED]

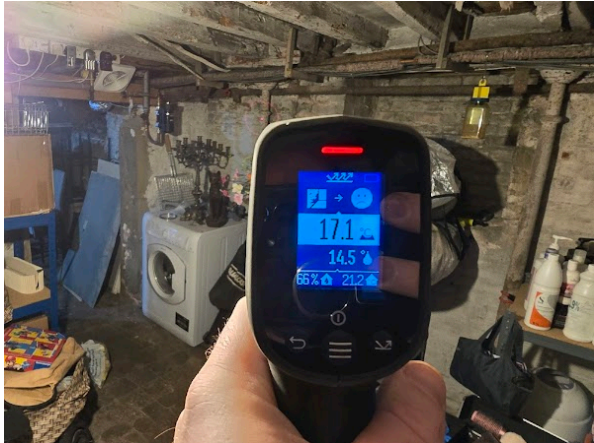
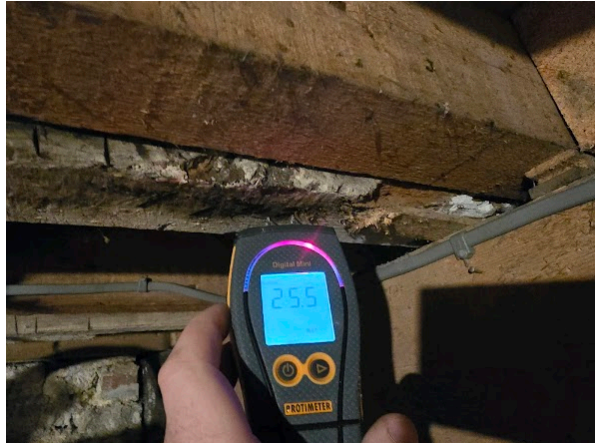
0 - Basement, Storage area

Basement timbers could be at risk of fungal decay		Severe Widespread	
Damp Reading		Wet (20+)	
Humidity (%RH)		070	
Condensation		Condensation Risk	
Defects		Poor sub-floor ventilation.	
Notes

Humidity reading showing at 66% RH		High moisture readings noted, suggesting timbers could be at risk of fungal decay	
Work Details		Work Cost	Work Status
Install humidistat controlled extract fan in the basement, ducted to rear outlet in the garden		1 item @ £350 Total Cost: £350.00	Scheduled Start Year: 2025 Priority: Urgent
Historic woodworm infestation		Minor	
Damp Reading		Wet (20+)	
Humidity (%RH)		065	
Condensation		Condensation Risk	
Defects		Possible untreated timbers	
Actions		Apply non-toxic insecticide to all exposed timbers in the basement	
Actions Priority		Desirable	
Notes		Whilst the infestation was noted to be historic , we would recommend for peace of mind that you apply a insecticide to all exposed timbers to ensure there is no further activity.

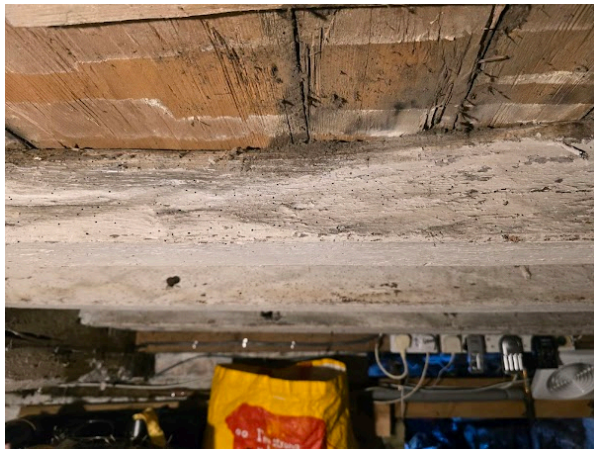
Historic bore holes noted

Item	Actions	Actioned
Historic woodworm infestation <i>Minor</i> <i>0 - Basement, Storage area</i>	<i>Apply non-toxic insecticide to all exposed timbers in the basement</i> <i>Desirable</i>

Treat all accessible timbers with non-toxic insecticide fluid

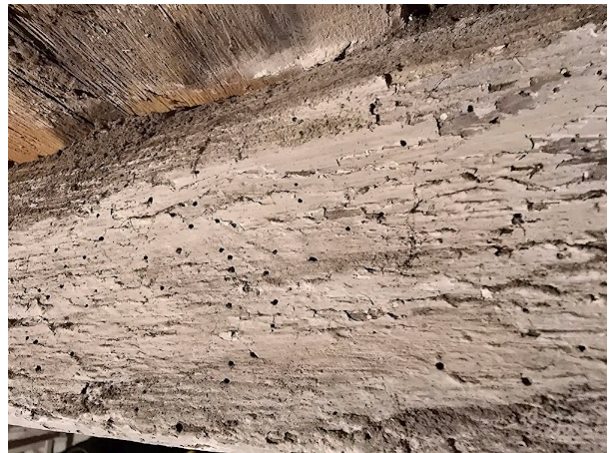
Close up of bore holes, noted historic

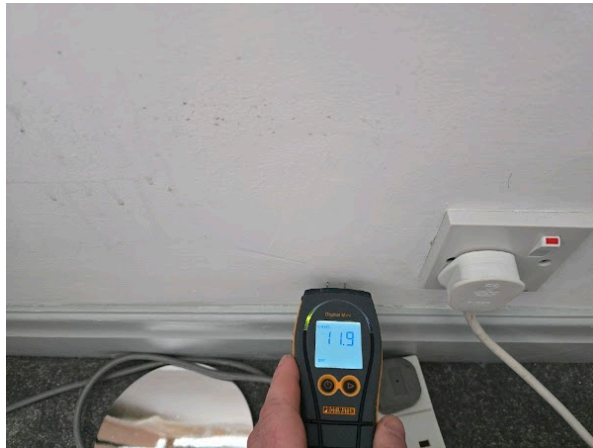
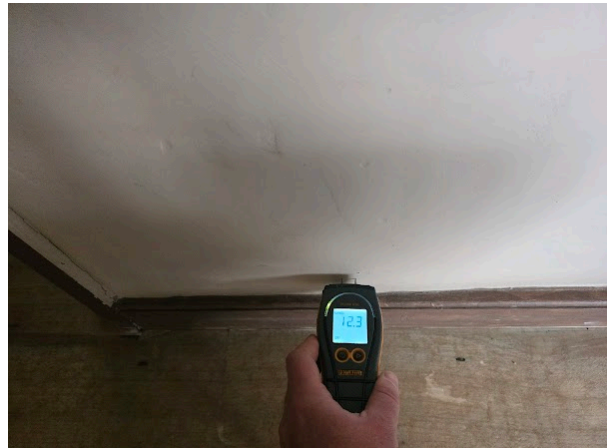
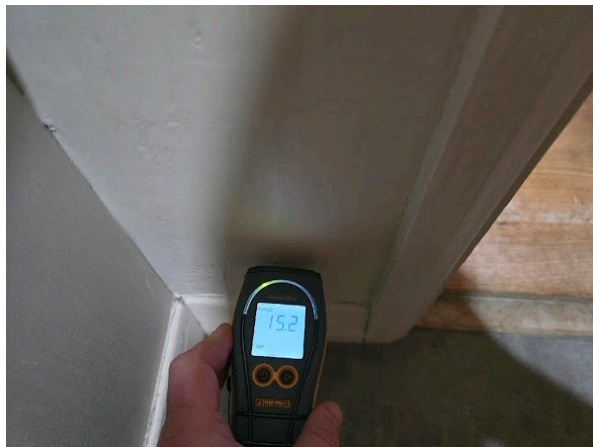
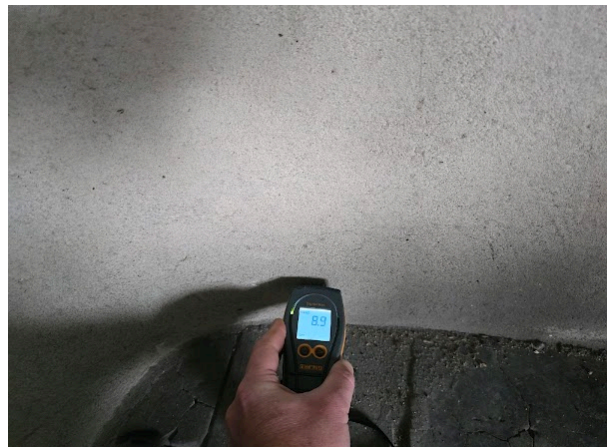
0 - Ground Floor, Damp readings

Dry moisture readings	<i>No Issues</i>
Damp Reading	<i>Dry (0-17)</i>
Humidity (%RH)	<i>050</i>
Condensation	<i>No Condensation</i>
Notes	<i>Moisture readings were taken throughout the rest of the ground floor and were noted to be below the threshold at which we would normally recommend remedial damp proofing works.</i>

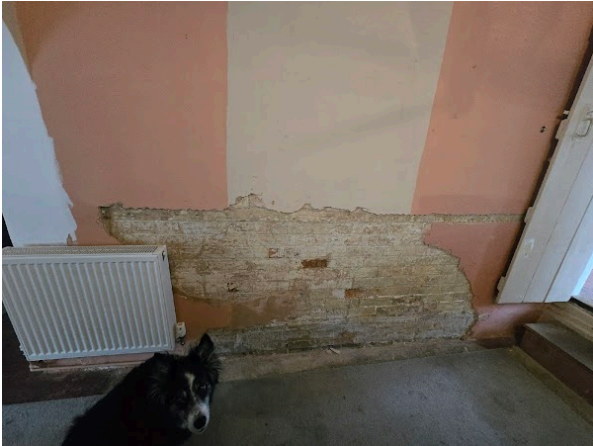
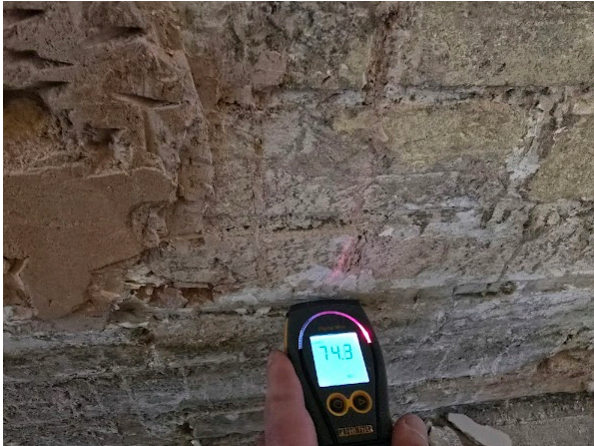
0 - Ground Floor, Study

Internal wall staining. Discolouration from ongoing moisture problems.		<i>Severe Localised</i>	
	Damp Reading	Wet (20+)	
	Humidity (%RH)	050	
	Condensation	No Condensation	
	Defects	<i>Poor sub-floor ventilation.</i>	
	Actions	<i>Add sufficient sub floor ventilation, allow wall to dry and replaster.</i>	
	Actions Priority	Essential	
	Notes	Not having these works carried out could lead to fungal decay to the sub floor timbers below the shower room

Damp wall located in study		Damp readings noted with the use of a Protimeter

Install at least 3 air bricks to the base of the wall adjacent to the shower room, spaced evenly apart, to allow for sub floor ventilation.	3 item @ £150 Total Cost: £450.00	Pending Start Year: 2025 Priority: Essential

Replaster wall <i>Replaster wall with salt retardant additive to ensure no risk of salt migration. Skim with plaster finish ready for redecorating.</i>	<i>8 m2 @ £90</i> Total Cost: <i>£720.00</i>	Pending Start Year: <i>2025</i> Priority: <i>Essential</i>
---------------------------------------------------------------------------------------------------------------------------------------------------------------------------	-----------------------------------------------------	-----------------------------------------------------------------------------

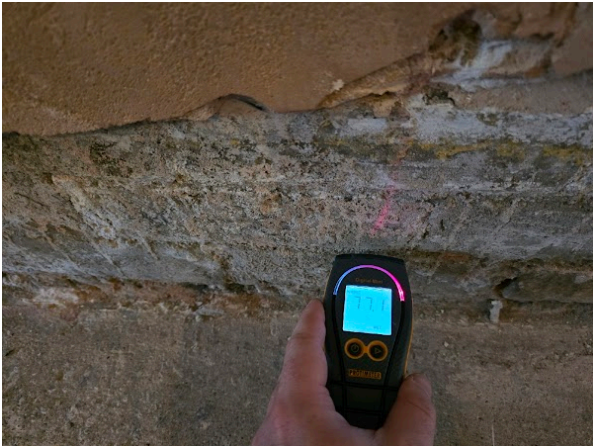
Moisture readings noted at the base of the wall with a hand held Protimeter			
Work Details	Work Cost	Work Status	
WALL 11.5CM: INSERT DPC INTERNAL Wall 11.5cm: Insert a new damp-proof course to the internal 11.5cm wall.	5 lm @ £60 Total Cost: £300.00	Pending Start Year: 2025 Priority: Essential	
Removal defective wall plaster <i>To wall adjacent to shower room.</i>	9 m2 @ £30 Total Cost: £270.00	Pending Start Year: 2025 Priority: Essential

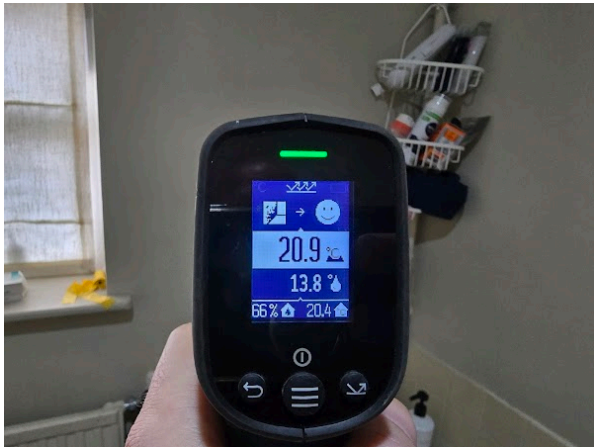
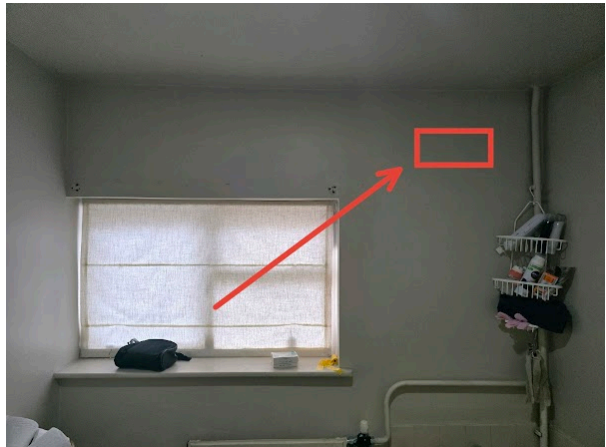
1 - First Floor, Bathroom

No mechanical ventilation		Minor
	Damp Reading	Dry (0-17)
	Humidity (%RH)	066
	Condensation	Condensation Risk
	Defects	Insufficient ventilation
	Actions	Fit or replace extractor fans in kitchens and bathrooms to improve airflow.
	Actions Priority	Desirable
	Notes	We note that there is not currently any black spot mould in the bathroom. However, new regulation dictates wet rooms should have some form of mechanical ventilation. And therefore, we would recommend installing a humidistat controlled extract fan in the bathroom on the first floor.

Humidity readings acceptable on day of the survey		Humidistat controlled extract fan recommended here

Work Details		Work Cost	Work Status
Install a humidistat controlled extract fan		1 item @ £350 Total Cost: £350.00	Pending Start Year: 2025 Priority: Desirable

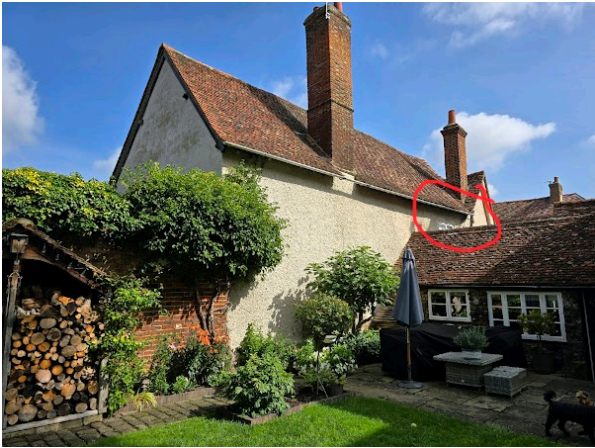
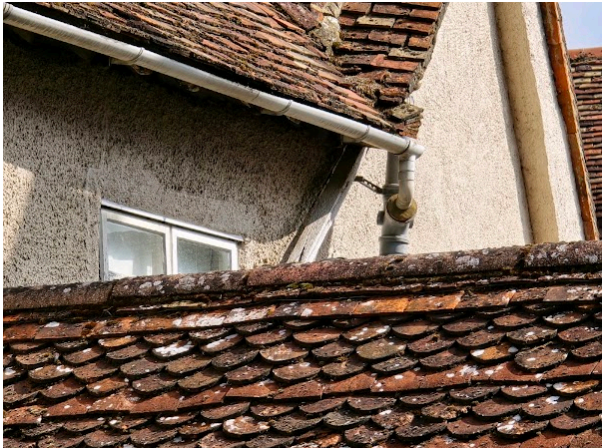
LHS Elevation, External wall

Leaking downpipe. Water escaping from damaged or misaligned pipes.		Severe Localised	
Damp Reading		Borderline (17-20)	
Humidity (%RH)		050	
Condensation		No Condensation	
Defects		Blocked or leaking downpipes.	
Actions		Clean and repair gutters to ensure effective rainwater drainage.	
Actions Priority		Essential	
Notes		Not having this repair carried out will lead to damp ingress to the property next door and will also lead to bathroom timber window decay.

Overflow/ leak located here		Rainwater downpipe currently discharging into soil stack pipe	
Work Details		Work Cost	Work Status
GUTTER: RENEW 150MM PVCU COMPLETE		10 lm @ £60	Pending
Gutter: Thoroughly clean and flush out gutters for the full elevation to ensure free water flow.		Total Cost: £600.00	Start Year: 2025
Replace with deep-flow gutter if possible			Priority: Essential

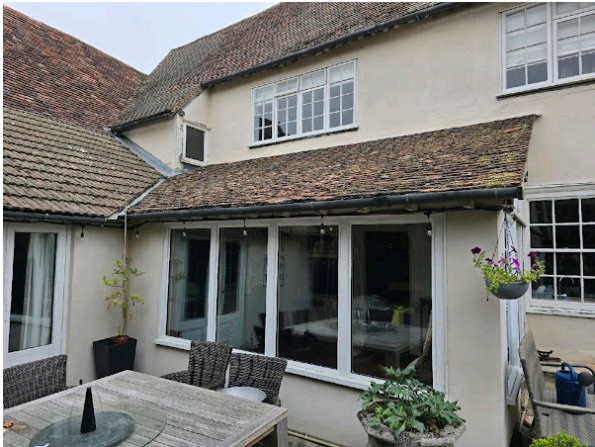
Broken clay roof tiles		Extreme
Damp Reading		Dry (0-17)
Humidity (%RH)		055
Condensation		No Condensation
Defects		Missing or damaged roof tiles.
Actions		Refix any loose roof tiles or slates to prevent water ingress.
Actions Priority		Essential
Notes		Failure to carry out this work could lead to moisture ingress to the rear garden room.

Rear garden room roof

Work Details	Work Cost	Work Status
Allow to remove and replace any broken tiles on the garden room roof.	6 m2 @ £100 Total Cost: £600.00	Pending Start Year: 2025 Priority: Essential

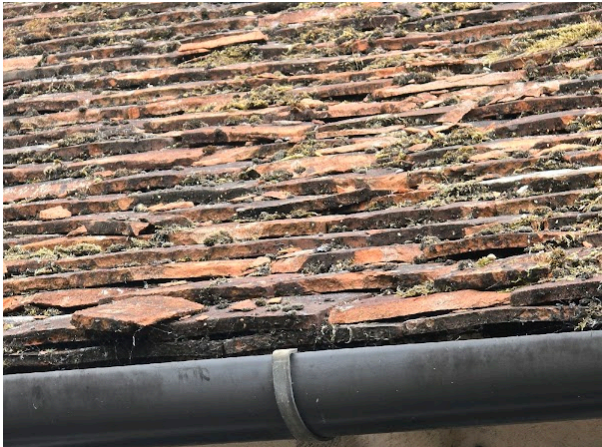
Close up of slipped tiles

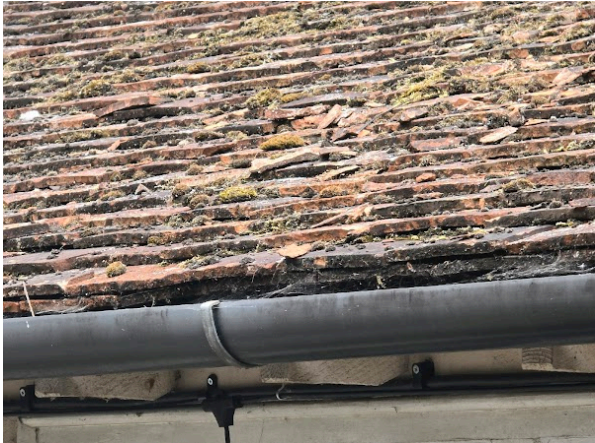
Close up of broken tiles

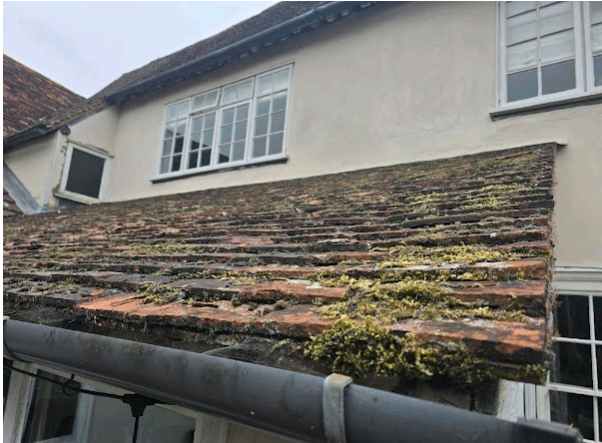
Close up of moss on roof

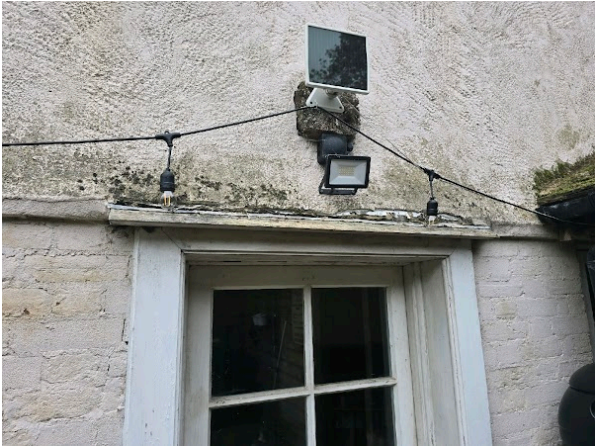
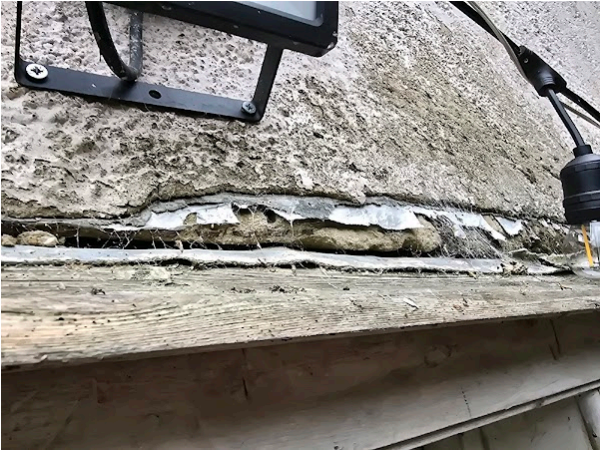
Rear Elevation, Kitchen

Penetrating damp. Rainwater entering through walls or openings.		Severe Localised	
Damp Reading		Dry (0-17)	
Humidity (%RH)		055	
Condensation		No Condensation	
Defects		Missing/ defective flashing	
Actions		Install new lead flashing detail above rear kitchen door to prevent water ingress	
Actions Priority		Essential	
Notes		We noted that the interior wall was currently dry. However, we believe if a flashing detail is not installed above the rear kitchen door eventually water ingress may occur.

Flashing missing from rear kitchen door		Flashing (possibly flashband) installed in the past	
Work Details		Work Cost	Work Status
Rake out mortar joint, and install lead flashing above rear kitchen door, before pointing in lead.		1 item @ £200 Total Cost: £200.00	Pending Start Year: 2025 Priority: Essential
